Old Place, Icklesham East Sussex; Roman Road Excavations 2024

Cameron Ross

Icklesham Roman Road – Interim Report

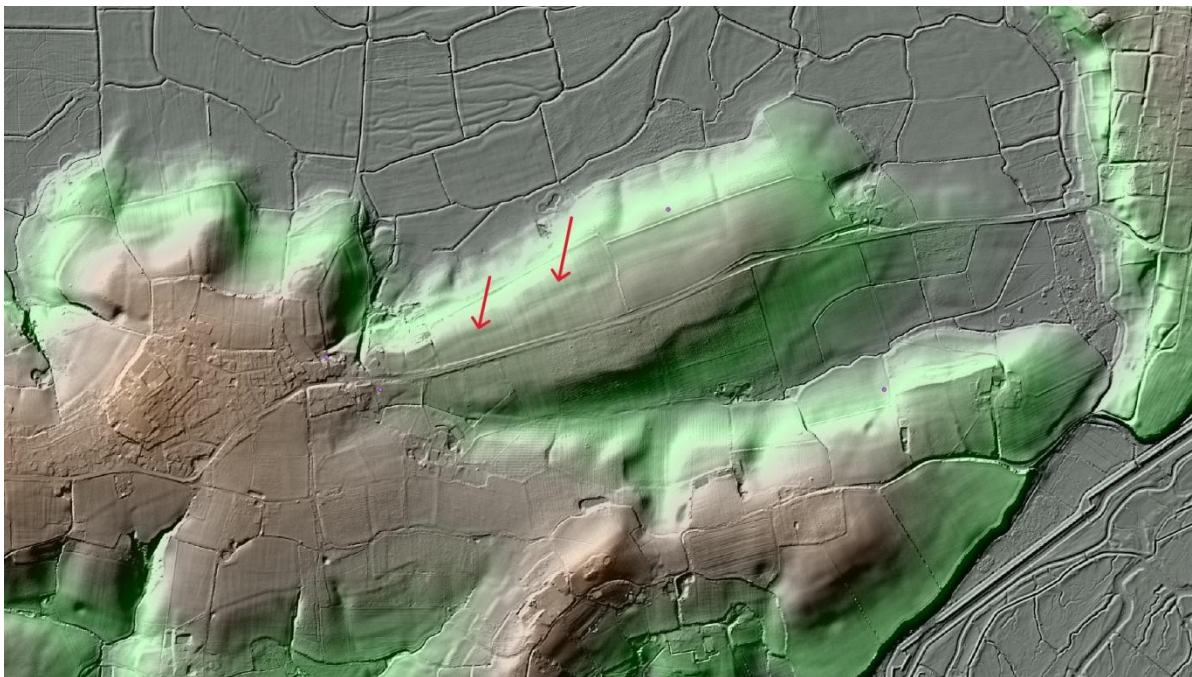
Fig (01) LiDAR image showing the impressions of a track-way or road indicated by the red arrows.

Archaeological investigation undertaken from October-December 2024 commissioned by Philip Merricks to further investigate LiDAR features (Fig:01) recognised by Andrew Scott from the then Winchelsea Archaeological Society representing an ancient road or trackway running east west across the Icklesham ridgeline from Icklesham village to Winchelsea Village parallel to the modern A259 road. The initial speculation was that; could this be the remains of a Roman road or Medieval track way? Further geophysics was undertaken by David Staveley on the 26th and 27th October specifically magnetometry to develop a more detailed survey, the results of which showed the clear outline of a 9-meter-wide double ditched metaled road representing the typical format of a Roman Road. Extended geophysics concluded that the road indeed continued east orientating towards Crutches Farm highlighting the suggestion that the road may terminate at a previously unknown Roman port or 'vicas' on the Pewes Marsh and West into the village of Icklesham itself suggesting a possible Roman footprint to the village. Excavation undertaken in November/December 2024 on a section of the road quantified this discovery detailing a well-constructed slag Metaled Road surface flanked by two V-shaped ditches, the north ditch cut containing a fragment of 3rd century Roman glass at its base.

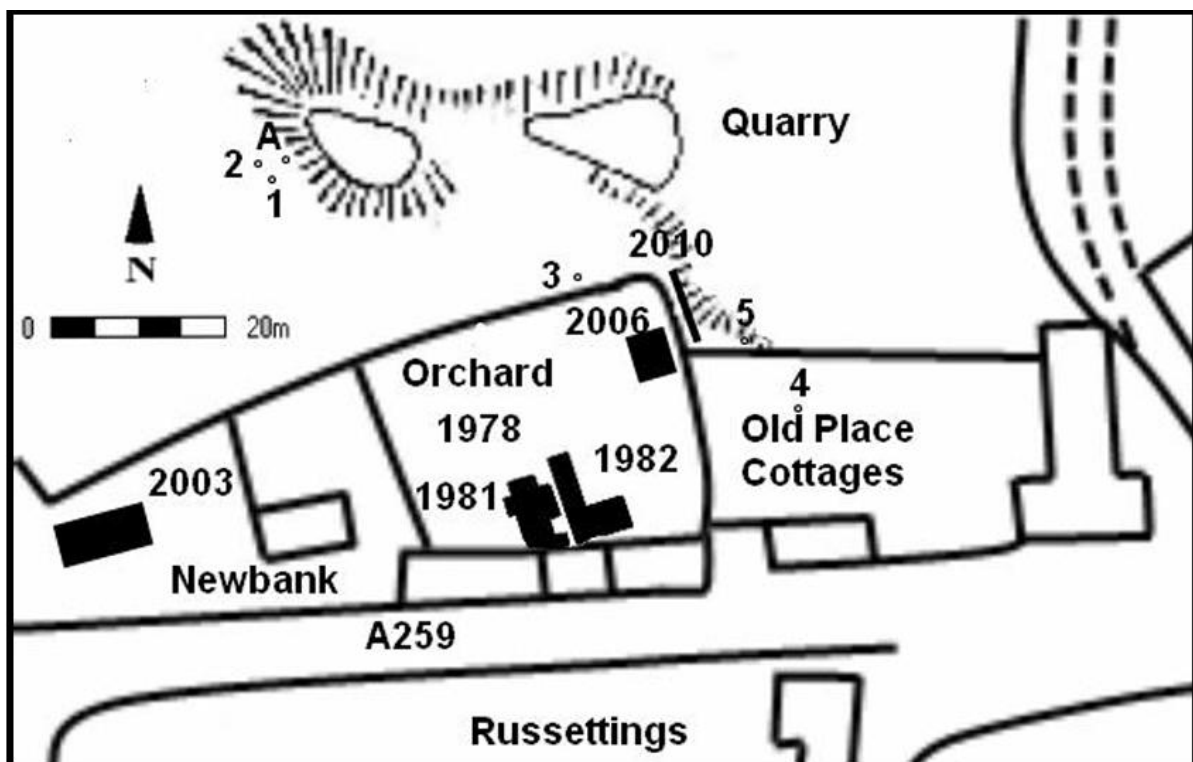
Fig (06) Plan of the locations of archaeological investigations carried out over time within the village of Icklesham north of the A259 road and centred around Orchard , Jasmine and Old Place cottages. (Cornwell 2013)

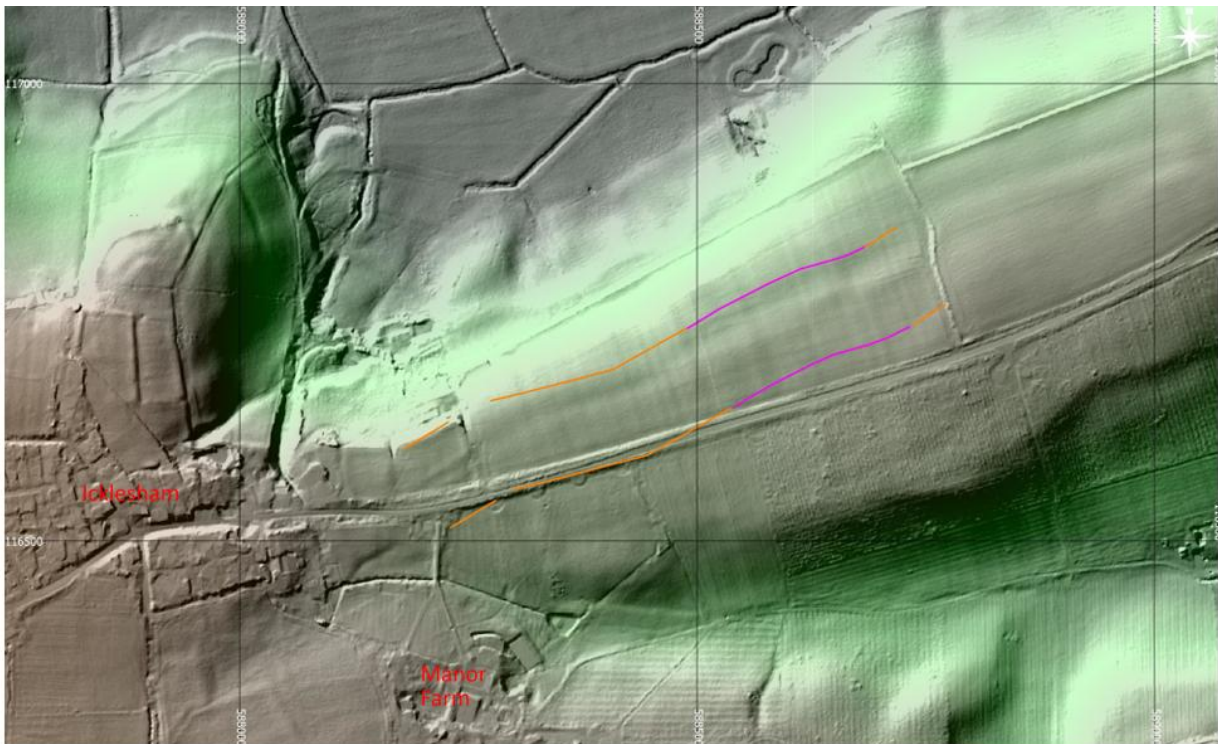
Fig (07) LiDAR image showing the location of the track-way/road anomalies.

There are three sections of geophysics showing the Roman road, shown in orange. The westernmost one, as the survey of the field is not finished, is not shown in this interim report. The road also appears on aerial photographs (GE2022), the line of which is shown in magenta.

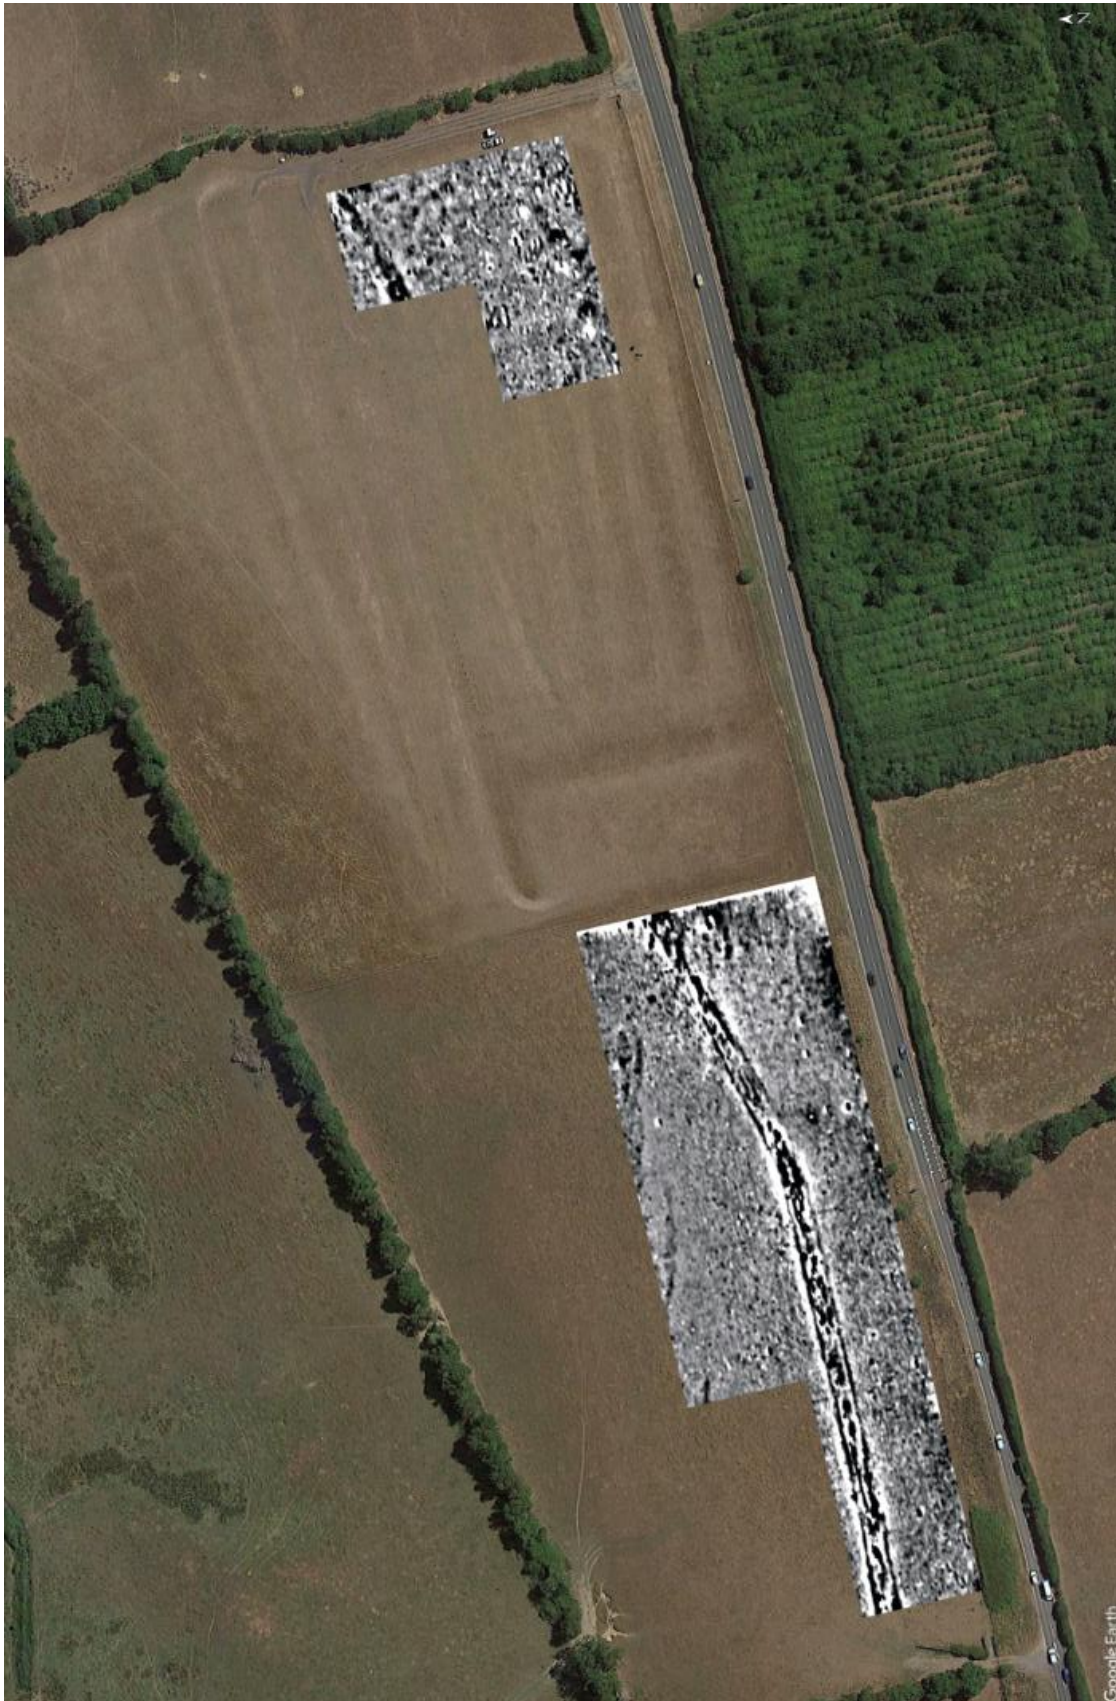
Fig (08) Magnetometer Results at two locations East and West showing clear indications of a road way.

The road appears clearly on the magnetometer results, with the intervening route visible on the Google Earth imagery, where the road ditch appears darker, and the surface appears lighter. There is a slight S bend in the road on the aerial photographs, between the two areas of geophysics. On the interpretation, possible archaeology is shown in dark green, the road surface in dark cyan, geological features in purple and modern metal in red. The top of slope of the LiDAR feature is shown as a pair of cyan lines. Annotated features are described below. The excavation area is shown as a red-bordered rectangle on the west side of the survey area.

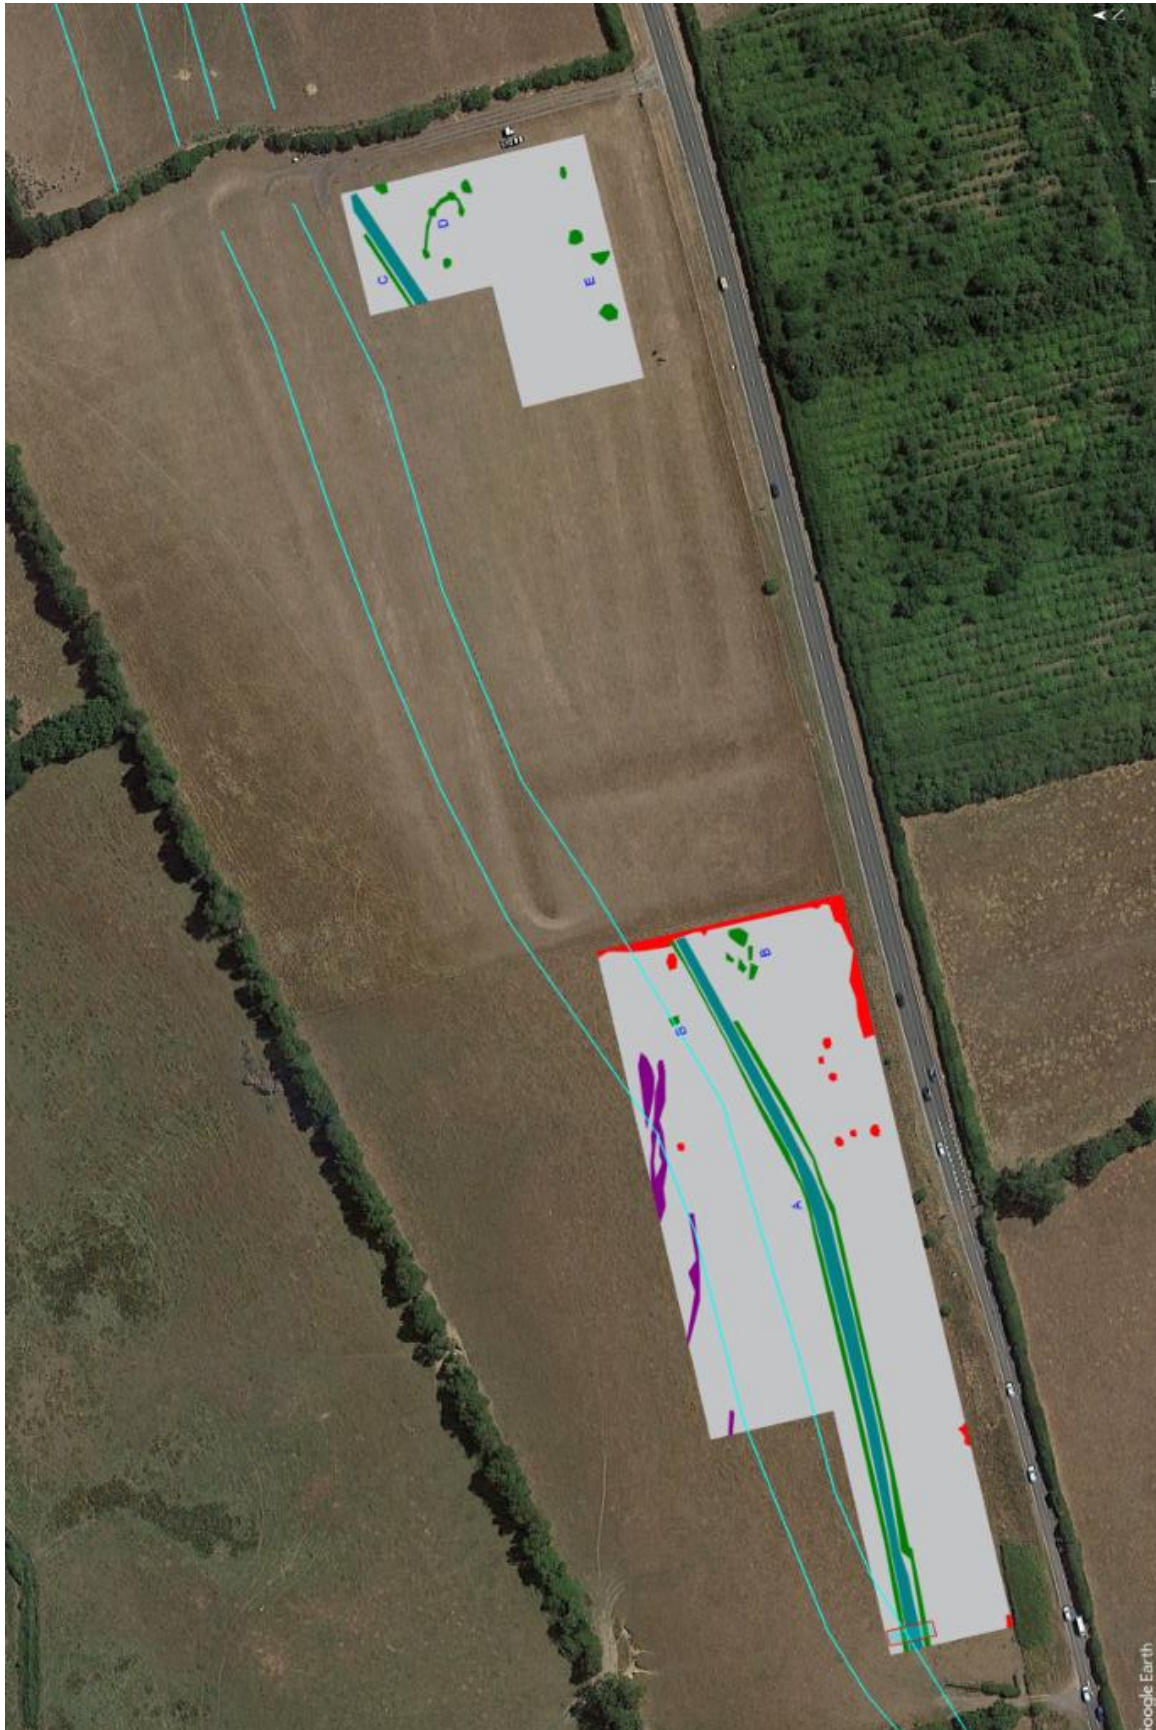
Fig (09) Magnetometer Interpretation of features located within survey area.

A) This is the Roman road. Where the side ditches are clear, they appear 7-8 metres apart, with the iron-slag surface showing in between. To the east, the road is not as clear, as there may be some modern disturbance here.

B) Some possible features are shown towards the eastern edge of the western survey area. They could be from the Roman period, but could also be modern disturbance or geological.

C) The road in the eastern survey area is not as well formed, with the side ditches barely visible.

D) There is a possible sub-oval enclosure here, with possible larger posts within the line of the enclosure. Given the noise in the area from geology and/or modern metal from the site being used as a car park, it is difficult to say for definite if this is archaeological.

E) As with feature D, the possible features here may be archaeological may also be modern, but are given here as possible archaeological features.

The Roman road here is a substantial slag surfaced road of the same form as the Roman road between Bodiam and Beauport Park, via the major iron-working settlements at Footlands and Oaklands Park. For the most part, it seems to stay 30m from the LiDAR feature, turning where the LiDAR feature turns. The exception is at the western end, where the road descends into the LiDAR feature as it heads west. The current thinking is that the LiDAR feature is a worn trackway from the early days of the Roman period settlement at Icklesham, which was replaced by the metalled road, using iron slag from the settlement.

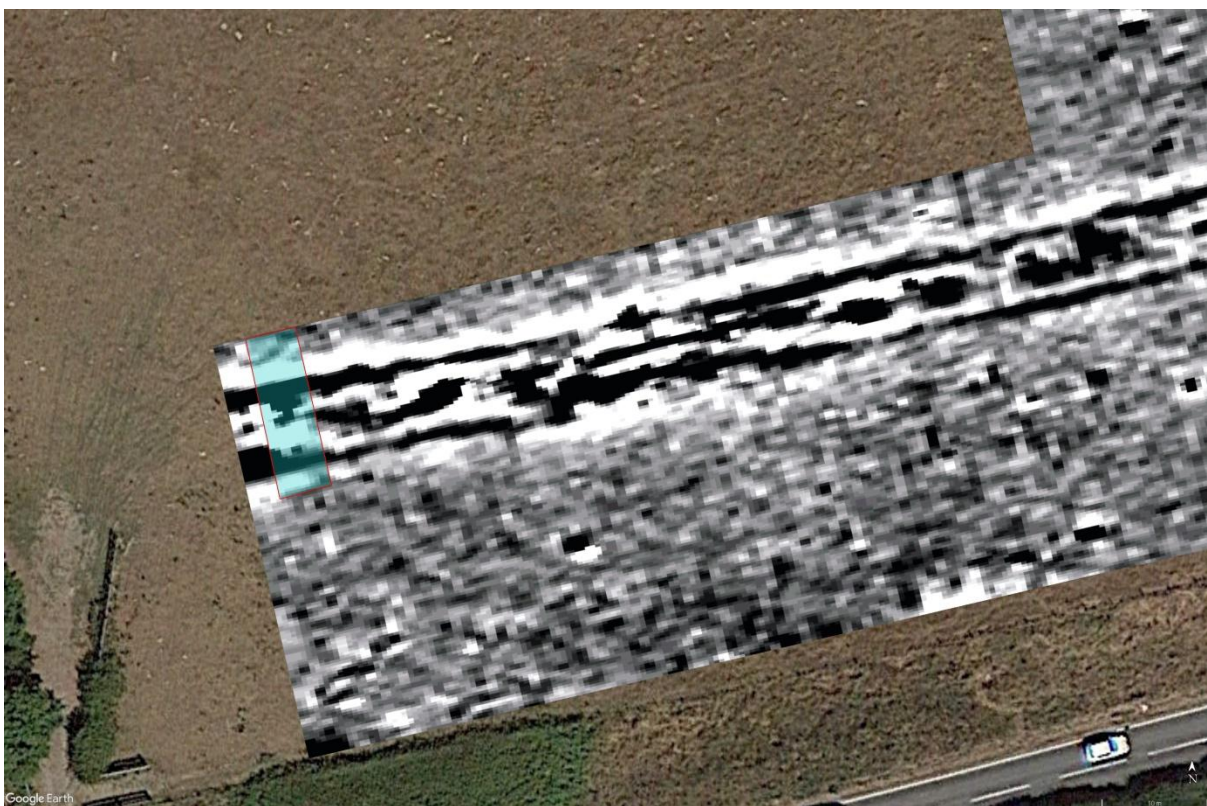
Fig (10) transect location Data:T1_1,588294.52,116600.93,33.78/T1_2,588289.75,116599.42,33.81
T1_3,588285.97,116614.21,33.42/T1_4,588290.59,116615.51,33.45.

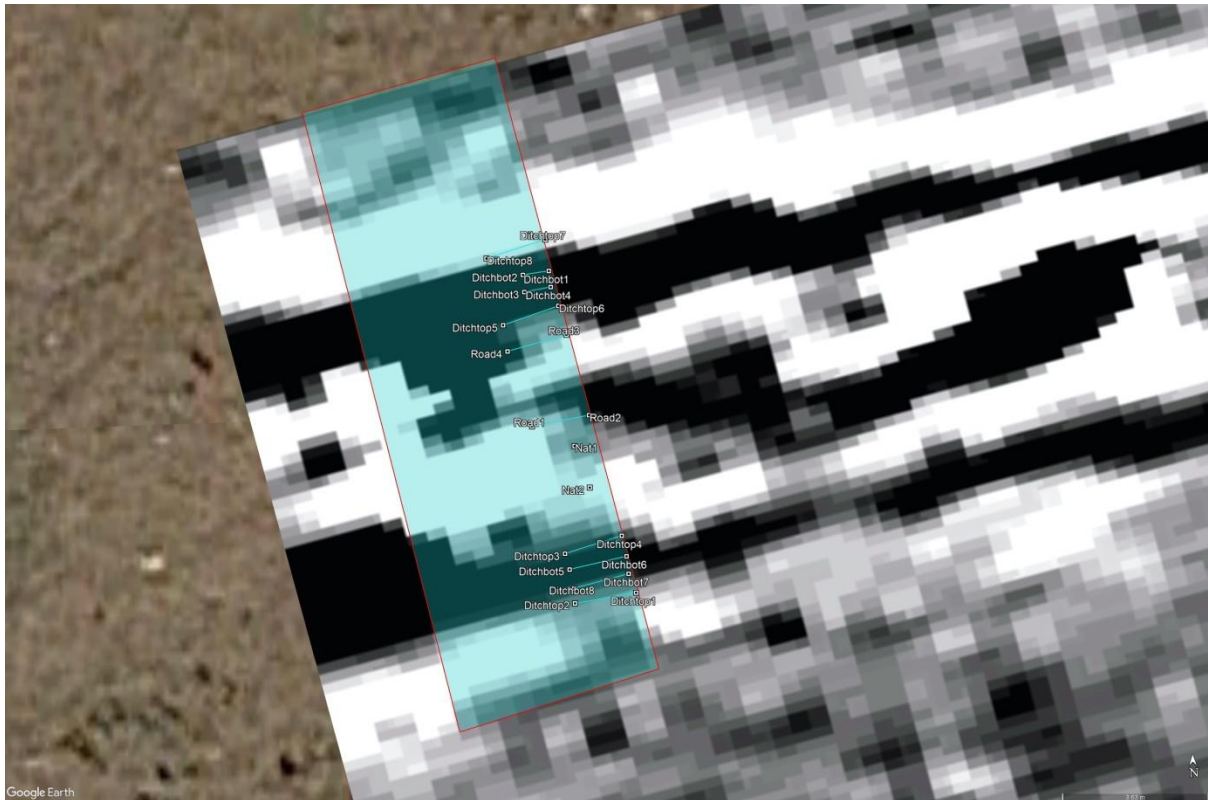
Fig (11) Transect raw data relevant to positioning and heights in the landscape.

Dichtop1,588294.01,116602.57,33.34
 Dichtop2,588292.49,116602.31,33.42
 Dichtop3,588292.24,116603.54,33.36
 Dichtop4,588293.65,116603.98,33.38
 Dichtop5,588290.69,116609.21,33.13
 Dichtop6,588292.07,116609.69,33.17
 Dichtop7,588291.75,116611.34,33.21
 Dichtop8,588290.28,116610.87,33.20
 Ditchbot1,588291.83,116610.56,32.75
 Ditchbot2,588291.19,116610.46,32.82
 Ditchbot3,588291.22,116610.04,32.76
 Ditchbot4,588291.88,116610.16,32.73
 Ditchbot5,588292.35,116603.15,32.95
 Ditchbot6,588293.77,116603.48,32.91
 Ditchbot7,588293.82,116603.04,32.92
 Ditchbot8,588292.47,116602.68,32.95

Road1,588291.41,116606.70,33.19
 Road2,588292.84,116606.98,33.21
 Road3,588292.27,116608.98,33.17
 Road4,588290.81,116608.56,33.19

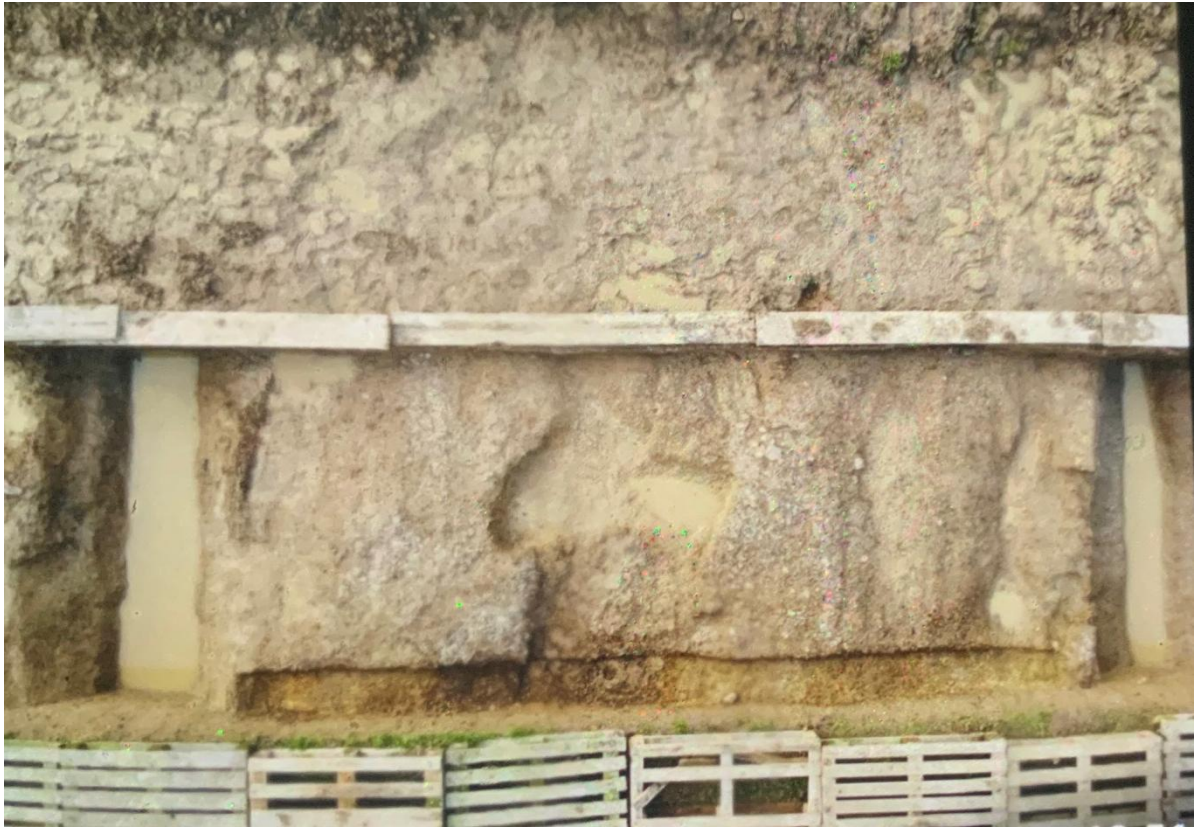
Fig (12) Drone image of the fully excavated road section (A). South Ditch (B) on the left and North Ditch (D) on the right. Road orientated East-West. North-South section of the Road taken on the Eastern elevation.

ditch fill suggesting parts of the top road surface being worn off or knocked off when in use. The entire area of the road between ditch cuts measuring around 6m. One of the most intriguing aspects of the iron slag metaled surface of the road in the northern sector was the presents of wheel rut impressions imprinted into the road surface. At least four distinct impressions were recorded but could be as many as six. These impressions were deep on the outer extremities of the road as the 'agga' dipped into the ditch cut and it is in this area that we see the possible extra three impressions as the cart wheels are being tracked even deeper into previous wheel ruts. The cart tracks are of various widths due to constant use yet could possibly be defined as being a standard 5cm wide wheel rim. Coincidentally it was while cutting a section of the road in this northern section of the road and in the same context as the deepest outer wheel ruts an iron Ox or Bullock shoe was recovered [04]. The shoe was heavily corroded and the amount of nail holes and style of shoe remains unclear yet due to the shoes context directly with the road has been assumed to be contemporary. During cutting of the same section yet another Ox or Bullock shoe [03] was also recovered on the southern extremities of the road in a similar condition.

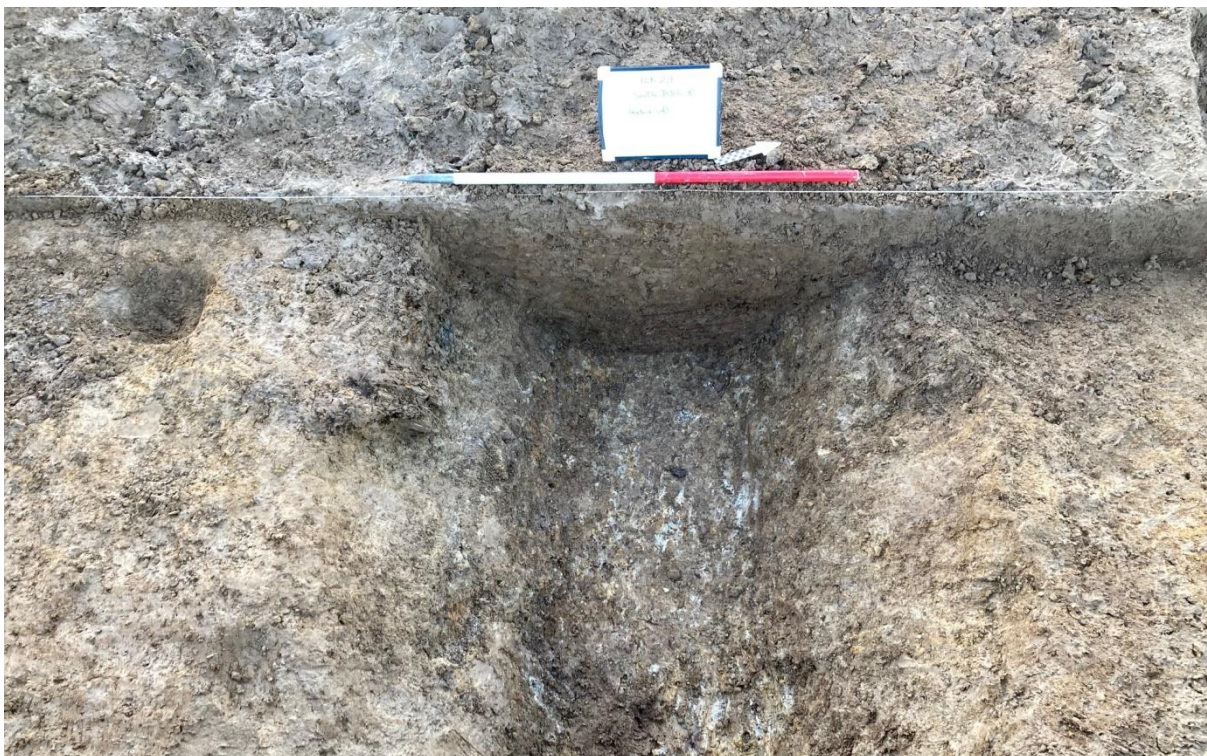
Fig (13) Southern Ditch (B) East facing section. Note the post hole to the centre left.

Two linear ditch cuts (*North D*) and (*South B*) orientated east west were also found bordering the iron slag metaled surface. The ditch cuts were uniform both measuring 1.7m wide containing a very dark brown grey fill. The ditch cuts were dug directly into the natural yellow Wadhurst clay interspersed with sand stone belts and pitted with iron stone and sand. Both ditch cuts were cut as v-shaped ditches bottoming out into a flat bottom flue presumably as they were dredged out or cleaned. The primary fill of both ditches was the same containing various levels of the same dark brown grey loam and sandy friable fill until 20cm off the base of the flat bottom of the ditch cut which was predominantly a grey clay and sandy clay silt. Large pieces of iron slag greater than 7-8 cm were found in this context. The depth of the northern ditch (ditch D) was 0.70m and the (South B) ditch cut 0.60m deep. A small amount of charcoal {03} was recovered from the very base of (Ditch D) yet again the sample was very small representing less than 5 grams. A further soil sample taken from the grey silty clay constituting the base fill of (Ditch D) was also taken {02}. It was in this context at the very base of the ditch cut was recovered an angled piece of green glass [02] around 2-4cm representing a plain body fragment, with no decoration and no rim, base or handle remaining yet most likely from a prismatic bottle or jar, identified as Roman possibly 3rd century AD (Broadley, 2024) perhaps a little earlier or later. The area to the north of ditch (D) was exposed to the natural clay for an extra 4m and no other features were identified. An area of 1.5m was also exposed on the very southern extremities of ditch (B) and a post hole (Feature C) was identified measuring 25cm diameter and 10cm deep, with a dark loam infill and pieces of Post Medieval peg tile [01] incorporating the top layer of the fill. The post hole was cut into the exposed natural sandstone clay and iron stone bands.

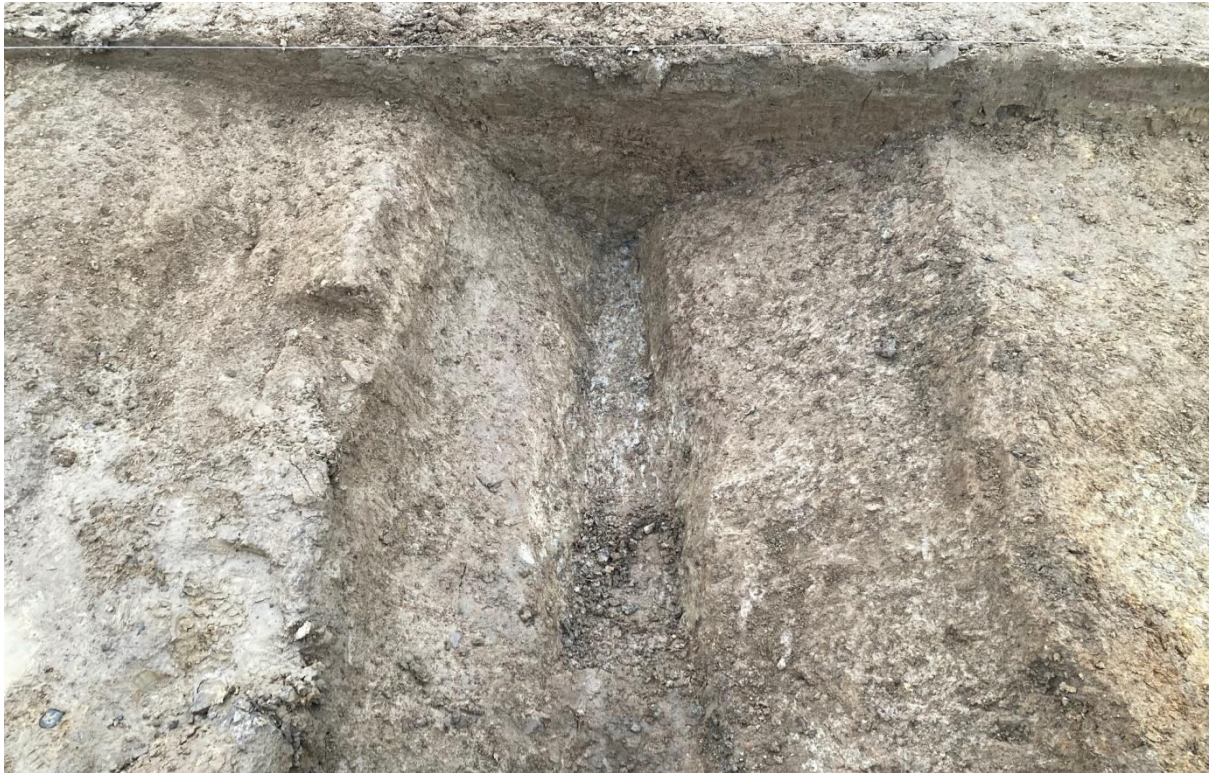
Fig(14) Northern Ditch (D) East facing section.

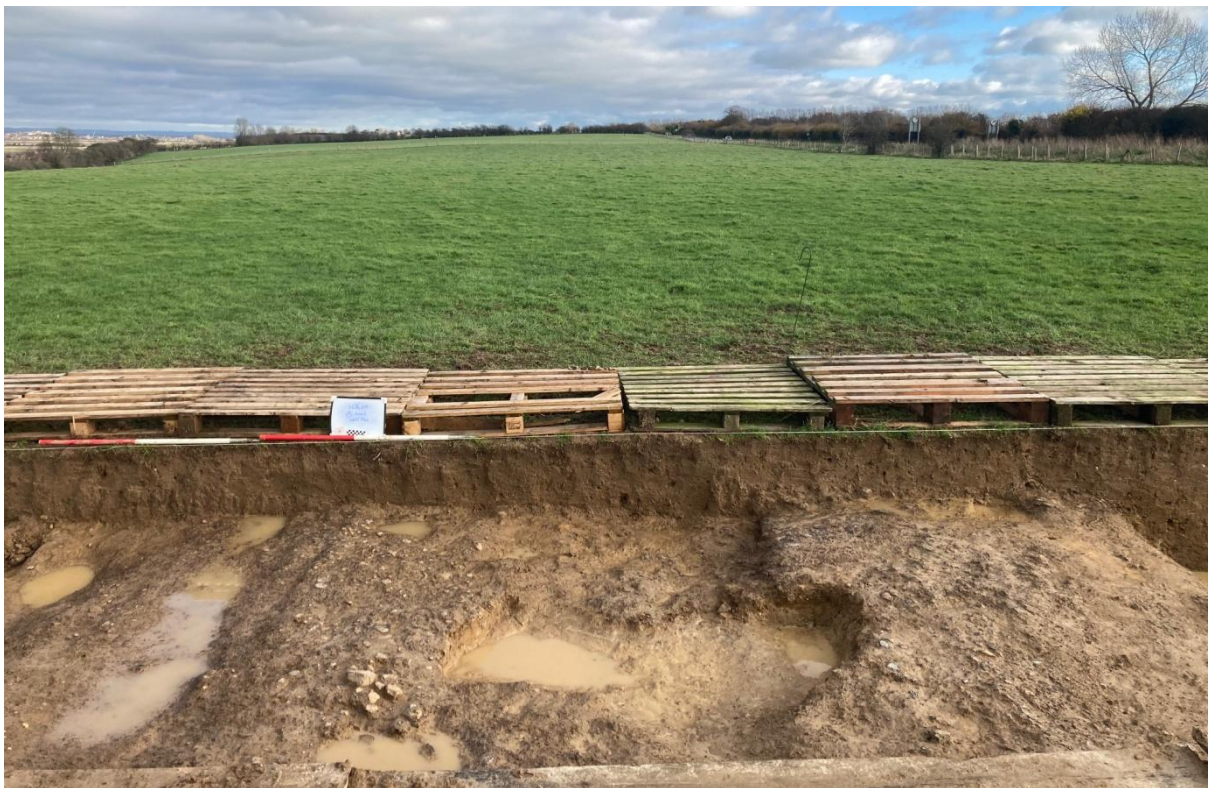
Fig (15) West facing section of feature (A) the road surface. Note the central 'agga' of the road has been removed.

The central aspect of the road was primarily a raised 'agga' made up of a naturally accourting belt of sand stone sheets and blocks interspersed with iron stone and sand. The metaled surface at this central location was robbed of the majority of iron slag material either deliberately or by the plough, though a residue of slag was still present in the section and in scattered areas. Either side of the 'agga' especially on the northern aspect of the road a very solid metaled surface was still present. This solid section extended for 2.5 meters and was made up of at least four grades of metaled slag. At the base layer directly laid onto the Ashdown beds were the smallest grades of iron slag no greater than 2cm diameter, this layer also interspersed with sand stone fragments and sheets 4-6 cm in diameter then topped with grades of slag 3-4cm in diameter, these levels both around 5cm in depth demoted the primary base layer to the road forming the most consistent matrix of the road, some areas deeper than others accounting to the undulation of the Ashdown beds. A third layer of iron slag was also evident measuring 4.5-6.5cm and a possible fourth layer of large iron slag measuring in at 7-8cm and greater. This layer had been almost totally removed due to possible deep ploughing, yet there was enough of it still present to suggest a specific material grade. Perhaps this larger grade of slag was the final capping to the road surface now almost lost. Indeed this grade was the most common size of slag found within the top soil and subsoil as well as was found at the base of the northern and southern road side

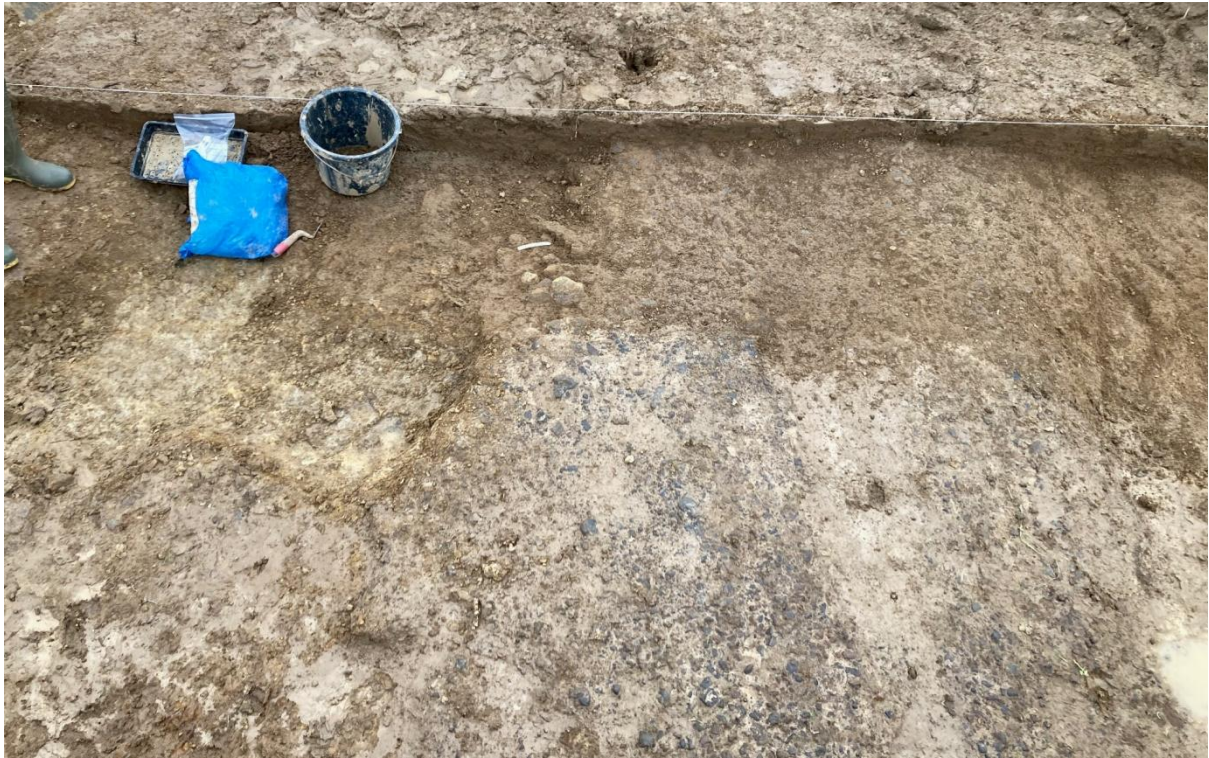
Fig (16) Central West facing aspect of the road (A) showing the main surface matrix of iron ore slag.

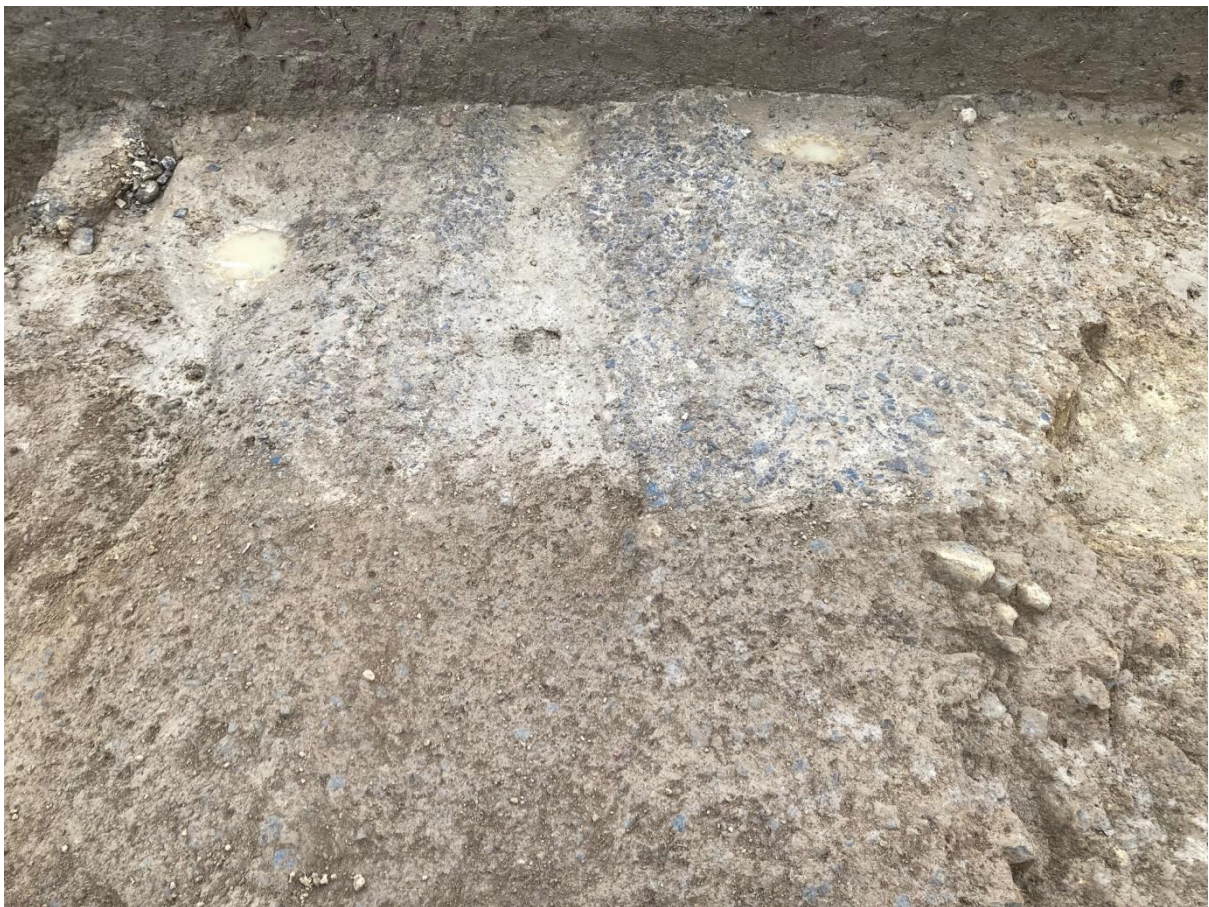
Fig (17) East facing Northern surface area of the road (A) showing cart wheel impressions into the metalized surface.

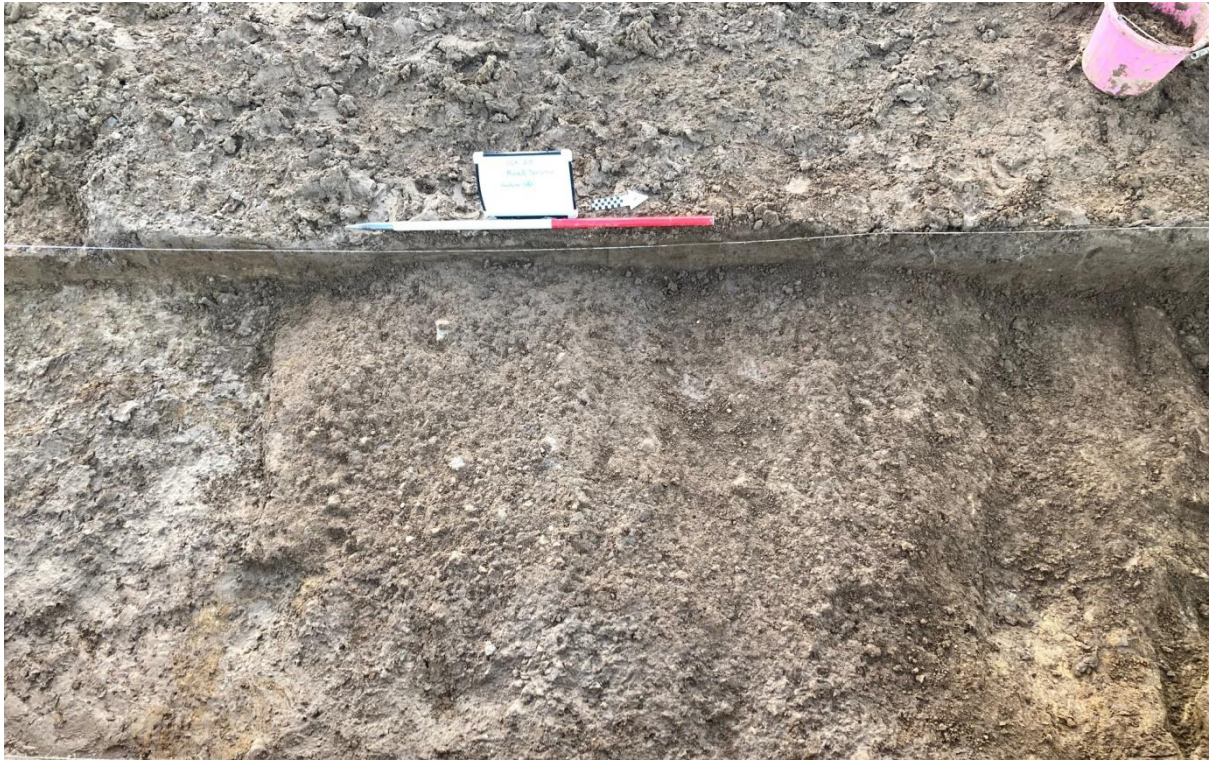
Fig (18) Cart wheel impressions being revealed on the northern aspect of the road (A) East facing section.

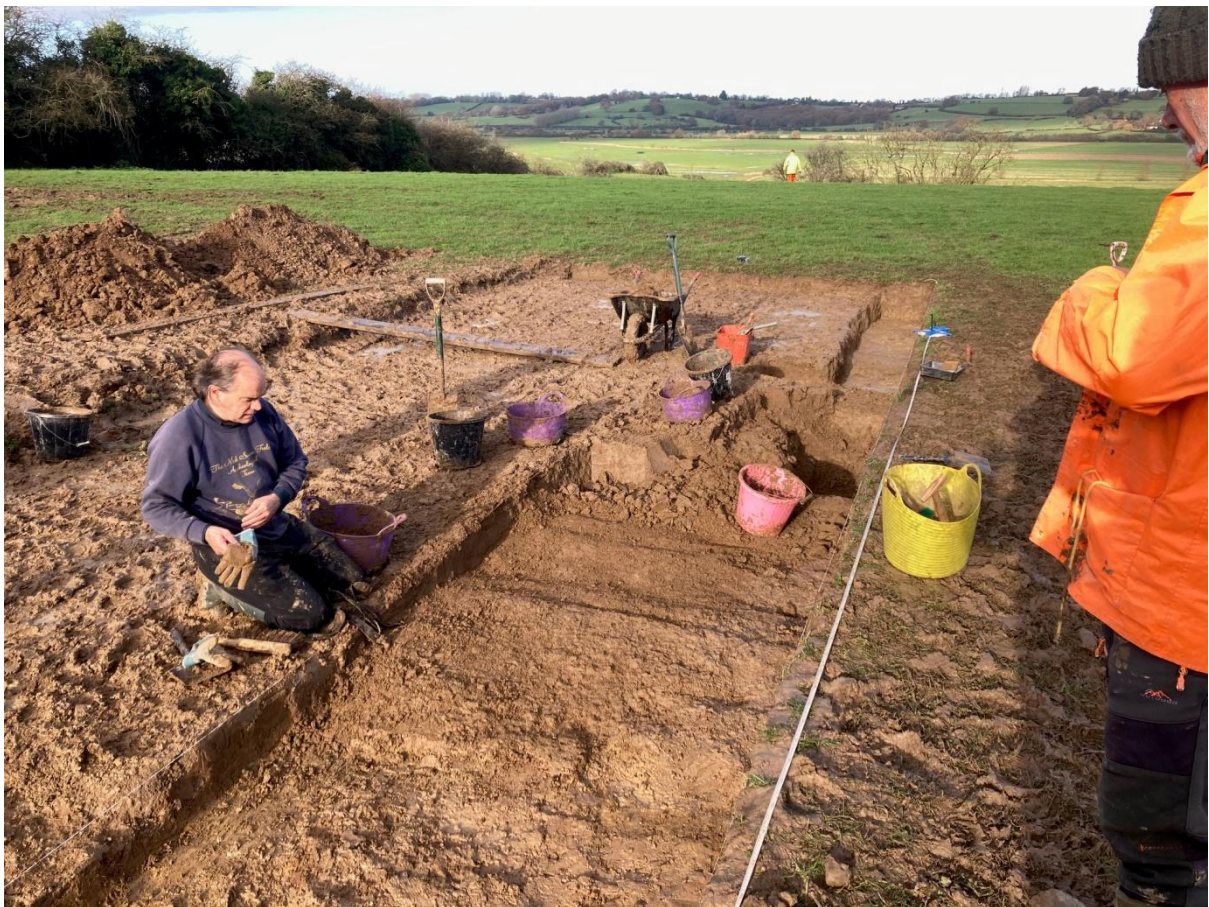
Fig (19) Cart wheel impressions under excavation of feature (A) running east-west, highlighted by the late afternoon sun. Note the position of the Brede valley of the ridgeline of the road at the top of the image.

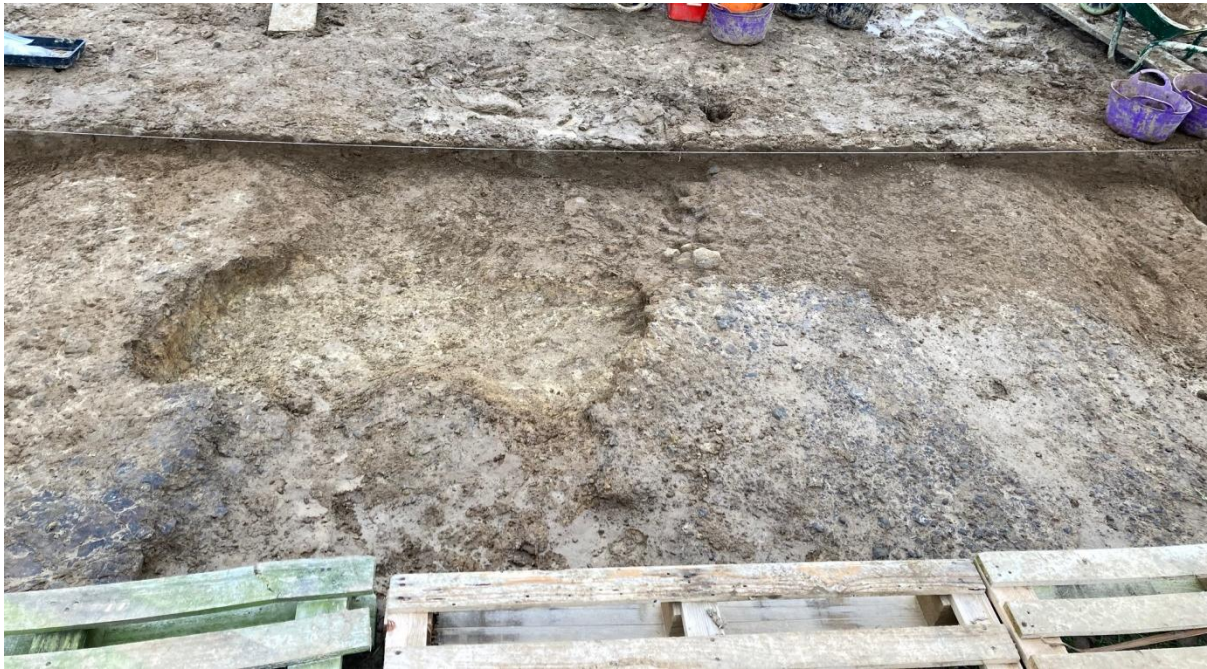
Fig (20) Historically removed central section of the road surface.

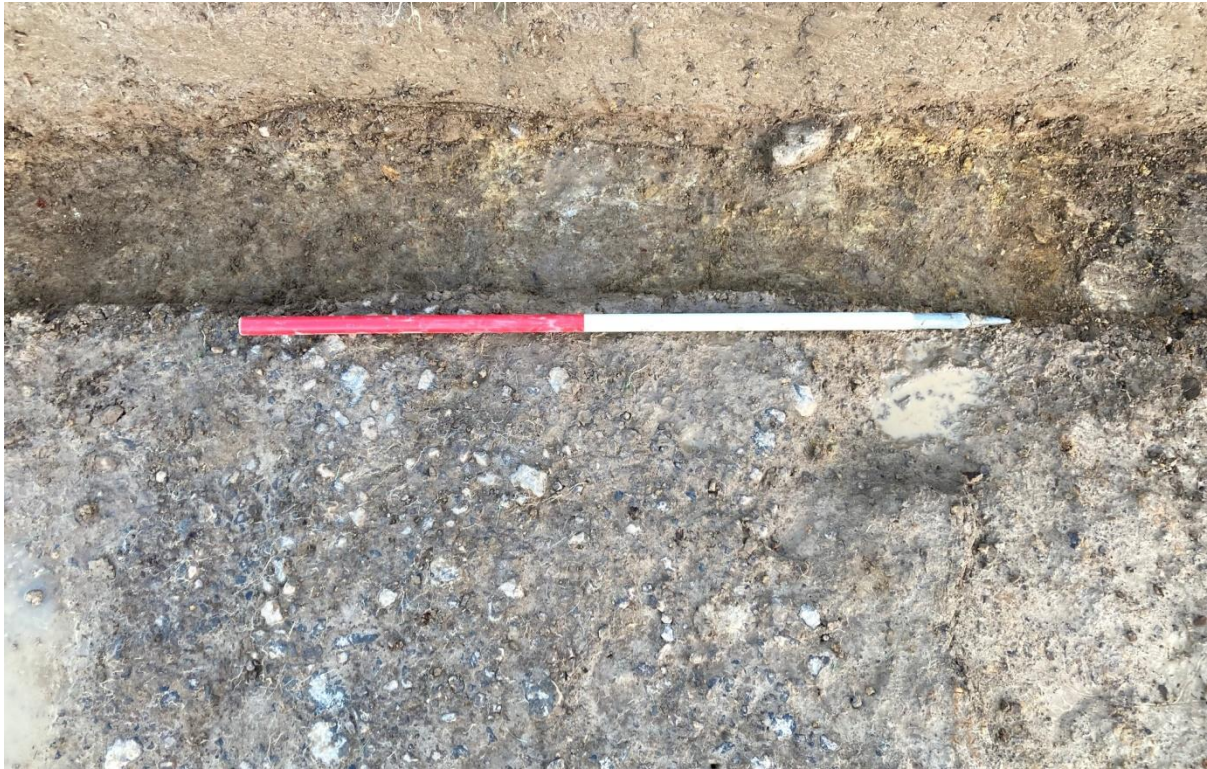
Fig (22) North facing section of the road surface (A) revealing the depth of the metal slag surface onto the natural sandstone and clay base.

The road surface was loosely packed with iron slag at the extremities bordering the ditches up until the ditch cut. Larger sandstone stones also seemed to aligned on the inner road side of the ditch to perhaps hold back the iron slag fill of the road, though this wasn't entirely clear as belts of natural sandstone where also evident in these areas as both ditch cuts had penetrated sandstone and iron stone beds. A very small amount of charcoal was recovered from within the road in only one location {01} yet the sample was less than 5 grams.

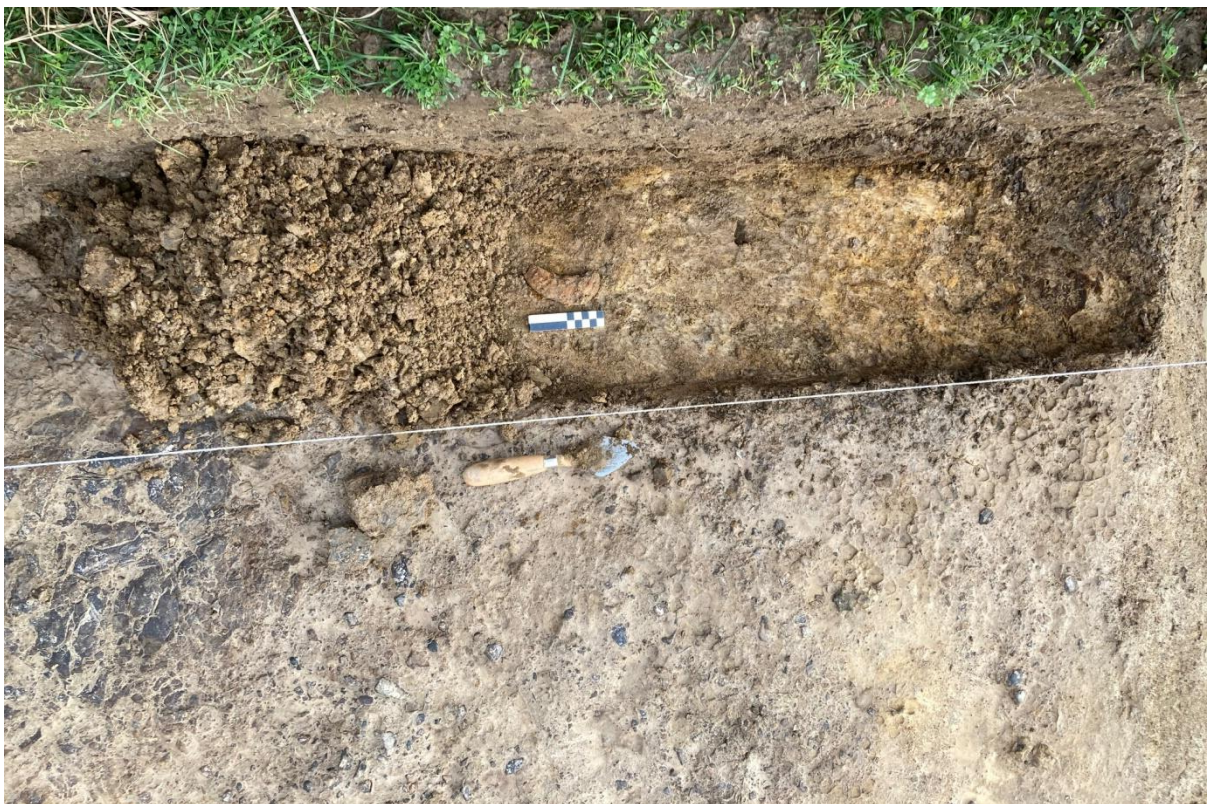
Fig (23) Sampling the road surface (A) and the discovery of the iron oxen shoe [3]
