Old Place, Icklesham East Sussex; Roman Road Excavations 2024

Cameron Ross

Icklesham Roman Road – Interim Report

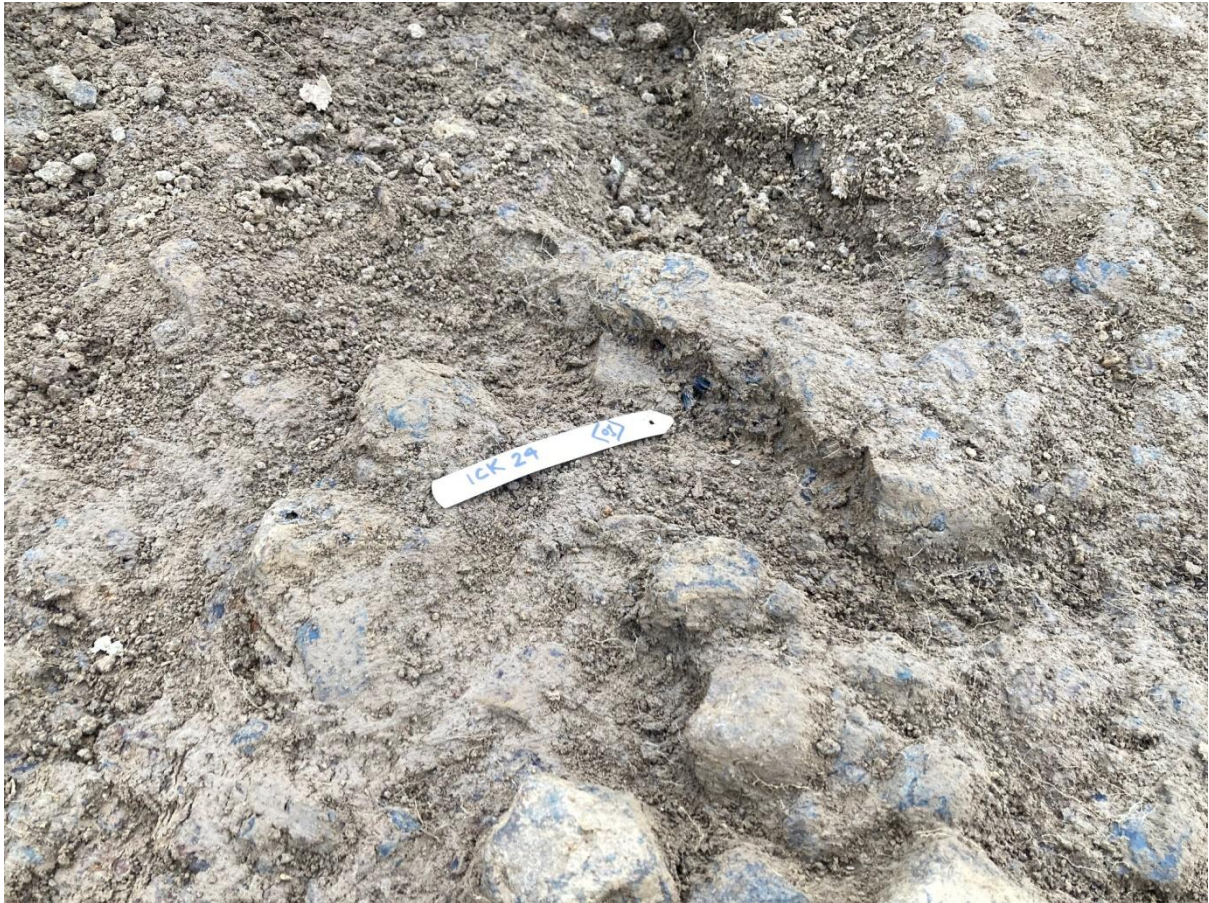
Fig (24) Charcoal [01] impeded within the road (A)

The road surface was loosely packed with iron slag at the extremities bordering the ditches up until the ditch cut. Larger sandstone stones also seemed to aligned on the inner road side of the ditch to perhaps hold back the iron slag fill of the road, though this wasn't entirely clear as belts of natural sandstone where also evident in these areas as both ditch cuts had penetrated sandstone and iron stone beds. A very small amount of charcoal was recovered from within the road in only one location {01} yet the sample was less than 5 grams.

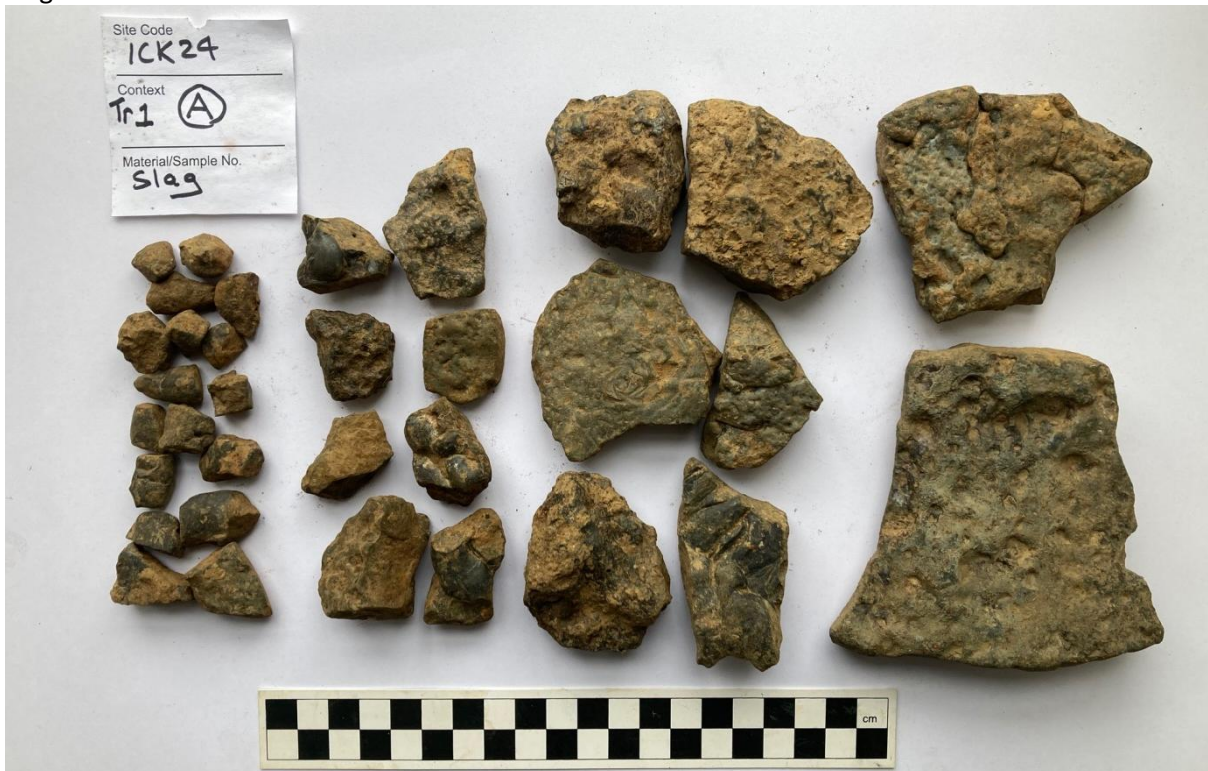
Fig(32) Four grades of iron slag found to constitute the road: 1-2cm; 3-4cm; 5-6cm; 7-9cm.

Slag recovered from 5.8m x .20m x .10m section:

Slag sizes	weight
1-2 cm	11.5 kg
3-4 cm	8.5 kg
5-6 cm	5 kg
7-9 cm	4 kg

Total weight: 29kg
